TECHNICAL SERVICE BULLETIN

8F35 Transmission - Shudder/Buck/Jerk While Driving Up To 35 MPH (57 Km/H) - Built On Or Before 11-Mar-2021

21-238904 November
2021

Ford 2019-2021 Edge	Transmission/Transaxle: (8F35)
Lincoln 2019-2021 Nautilus	Transmission/Transaxle: (8F35)

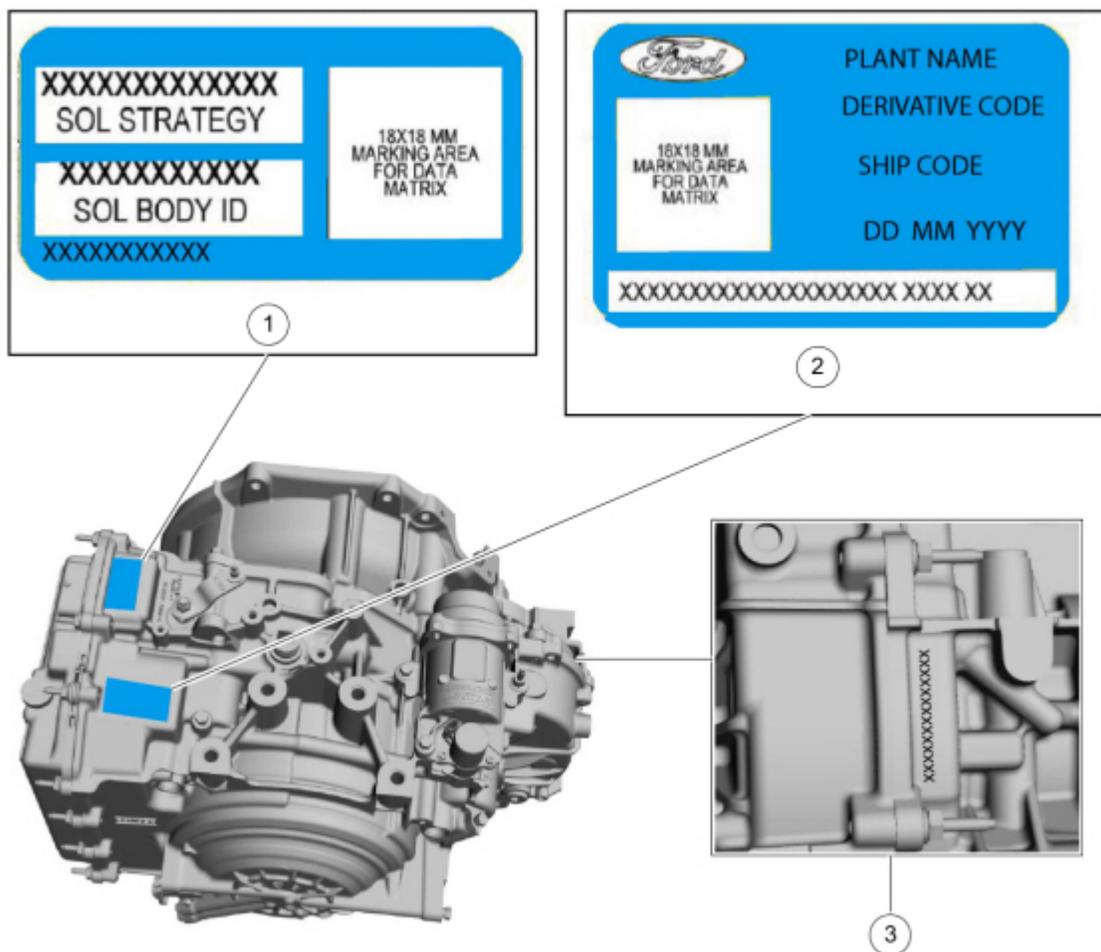
Figure 1

1. Reprogram the PCM using the latest software level of the appropriate Ford scan tool.
2. Identify the transmission solenoid strategy number located on the transmission case. (Figure 1)

3. Utilizing the transmission solenoid strategy 13-digit number, reprogram the solenoid strategy following the Transmission Strategy Download procedure. Refer to Workshop Manual (WSM), Section 307-01A.
